ASBESTOS AND LEAD SURVEY

NEZ PERCE VILLAGE (BUILDING 677)

WASHINGTON STATE UNIVERSITY
PULLMAN, WASHINGTON

Project No. E09034

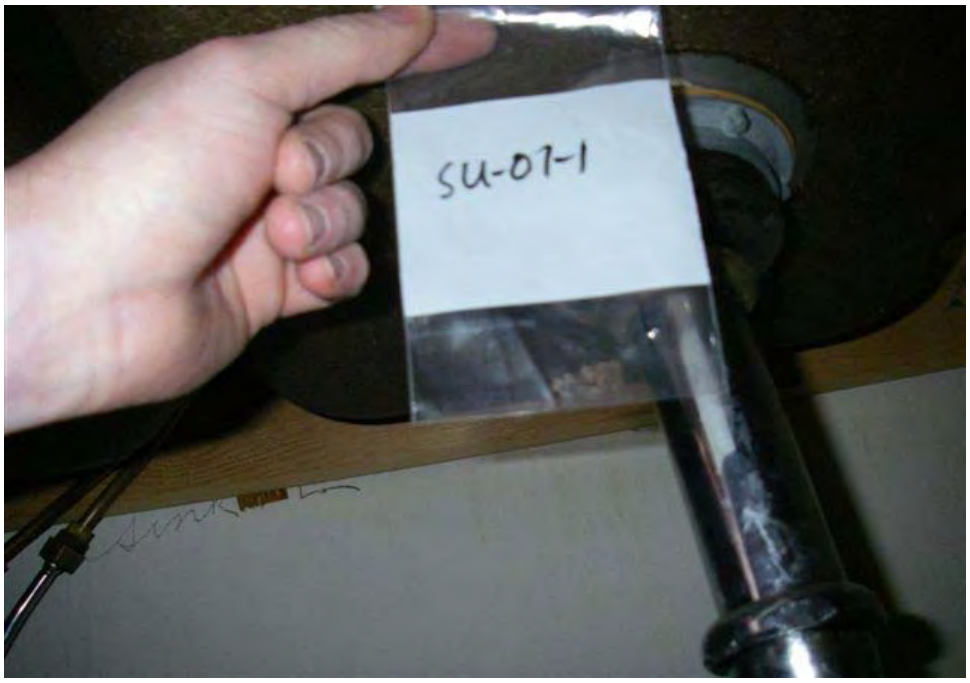
Sample No. SU-01-1, Sink Undercoating (black).

Sample No. SU-02-1, Sink Undercoating (white).
