ASBESTOS AND LEAD SURVEY

CHINOOK VILLAGE (BUILDING 679)

WASHINGTON STATE UNIVERSITY
PULLMAN, WASHINGTON

Project No. E09034

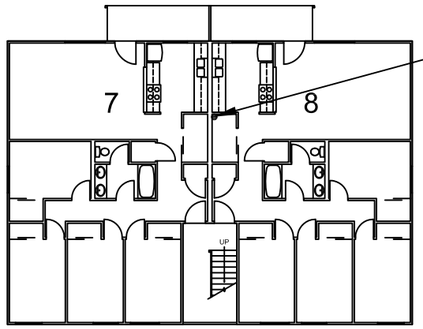
Building B (1st Flr.)

GWB-01-2, ***ST-07-3***

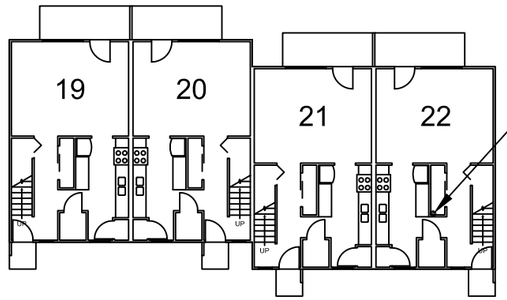
Building D (1st Flr.)

GWB-01-4, ***ST-07-6***

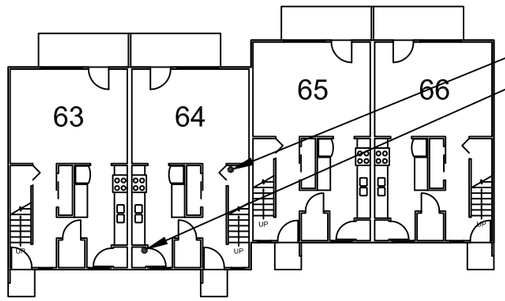
Building N (1st Flr.)

GWB-01-12, ***ST-07-15***
SVF-01-3

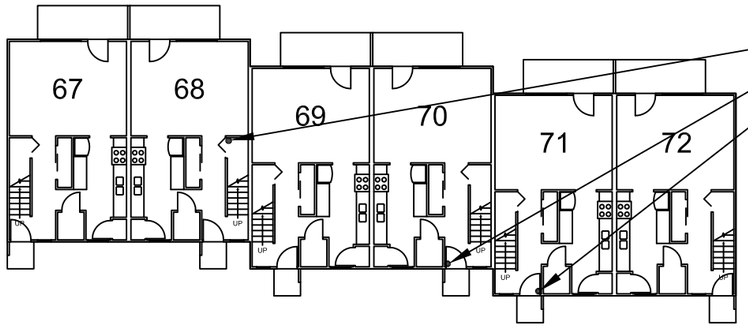
Building P (1st Flr.)

GWB-01-13, ***ST-07-16***
SVF-03-2
SVF-02-2

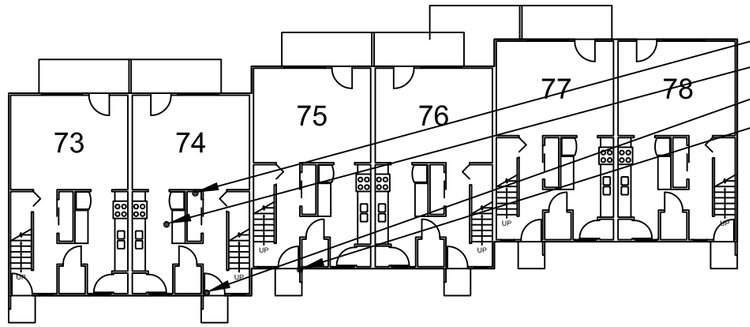
Building Q (1st Flr.)

ST-07-17,
GWB-01-14
SVF-01-4
SVF-03-3
SVF-02-3

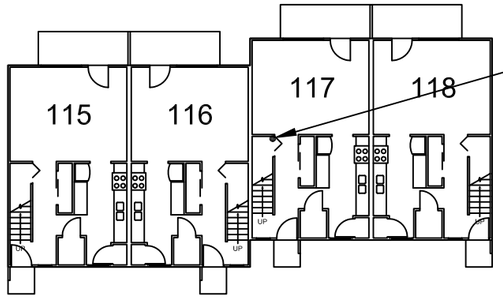
Building Y (1st Flr.)

GWB-01-22, ***ST-07-25***

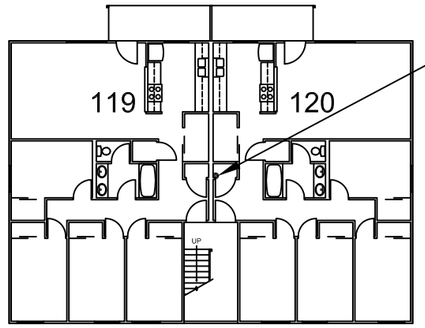
Building Z (1st Flr.)

GWB-01-23, ***ST-07-26***
