ASBESTOS AND LEAD SURVEY

STEPTOE VILLAGE (BUILDING 665)

WASHINGTON STATE UNIVERSITY
PULLMAN, WASHINGTON

Project No. E09034

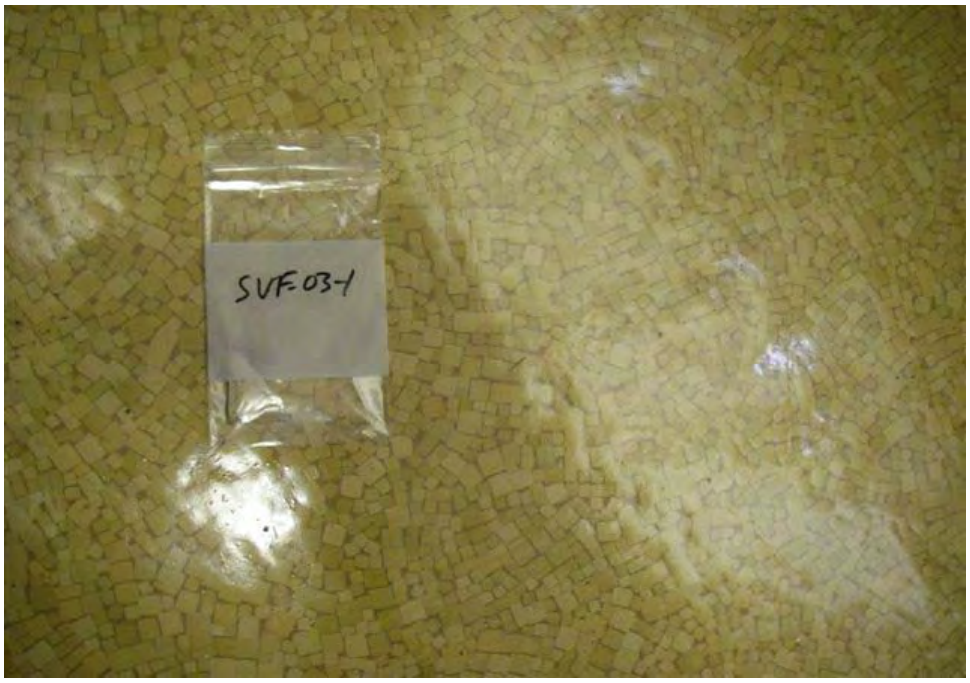
Sample No. SVF-03-1, Asbestos-Containing Sheet Vinyl Flooring (tan square terrazzo pattern) with Non Asbestos-Containing Mastic (yellow).

Sample No. SVF-04-1 and SVF-04-2, Asbestos-Containing Sheet Vinyl Flooring (tan/grey with brown grout square terrazzo pattern) with Non Asbestos-Containing Mastic (yellow).

Sample No. VT-01-1, Asbestos-Containing Vinyl Floor Tile (lt. green 12”x12” with green splotches) with Non Asbestos-Containing Mastic (brown/yellow).

Sample No. VT-02-1, Asbestos-Containing Vinyl Floor Tile (tan 12”x12” with brown/white streaks) with Mastic (black).

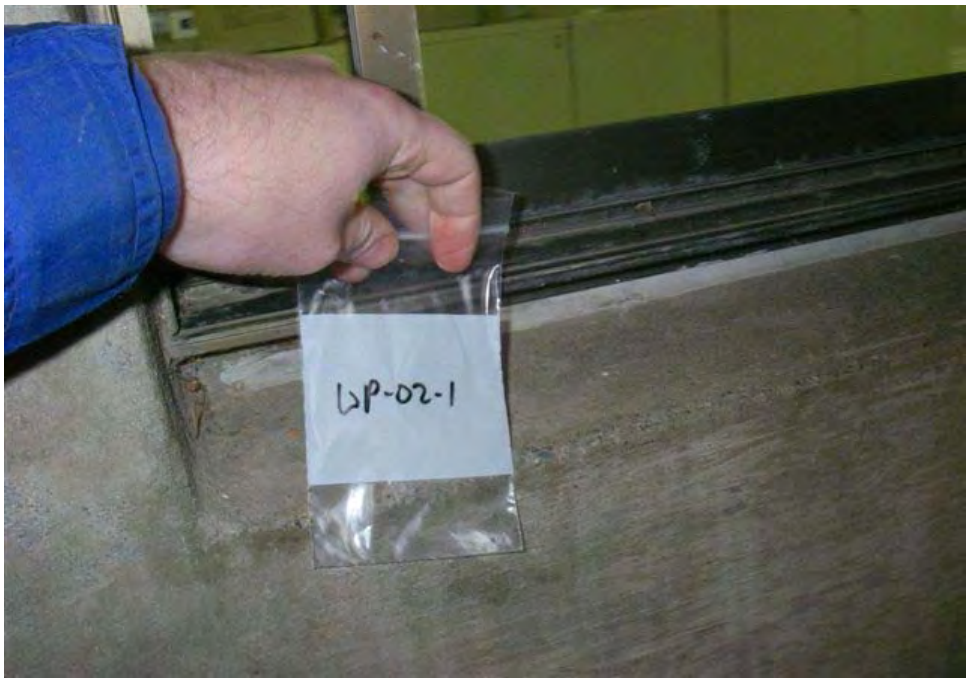
Sample No. WP-02-1, Window Frame Caulking (grey).

Sample No. SU-02-1, Sink Undercoating (black).

Sample No. SS-01-1, Seam Sealant (black on concrete joints).

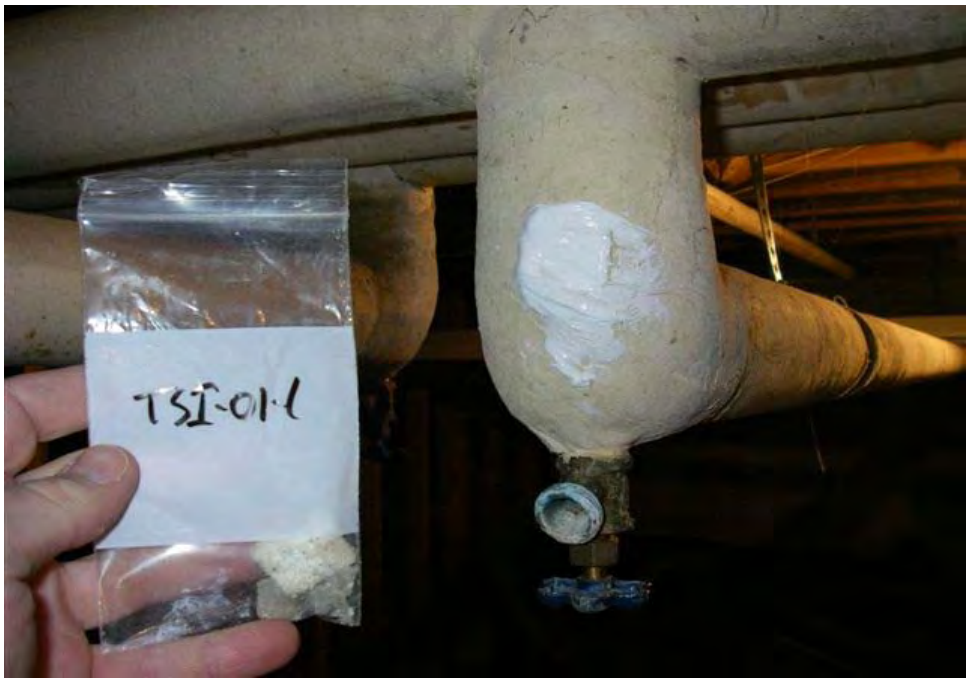
Sample No. TSI-01-1 to TSI-01-3, Thermal System Insulation (hard mudded fittings on small fiberglass lines).

Sample No. TSI-02-1 to TSI-02-3, Thermal System Insulation (boiler system tank insulation).
